Error 010 Islanding

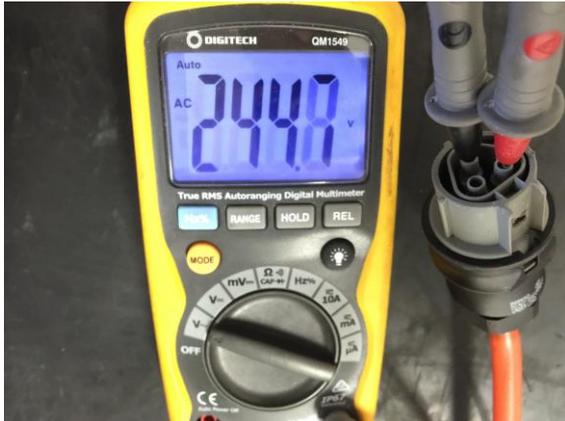
Figure 2 External AC voltage

If the technician just installed the system and is on-site, and error 010 occurs, test for the external AC voltages of the AC plug (Figure 2). If it has the voltage, then take the inverter cover off and measure the internal voltage at the AC terminal (Figure 3), as per the following instructions.

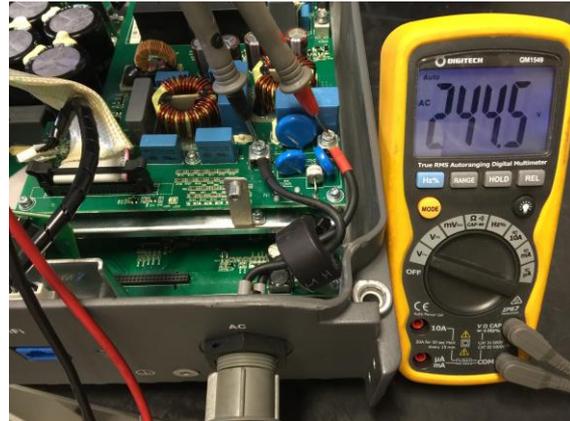
Figure 3 Internal AC voltage

If the technician measures that the internal circuit board terminals have a voltage (around 240 Vac), but the inverter still shows error 010, **then the inverter needs to be replaced.**

However, if the technician measures that the internal circuit board terminals have no voltage, then there will be an issue with the connection or installation. Please follow below instructions.

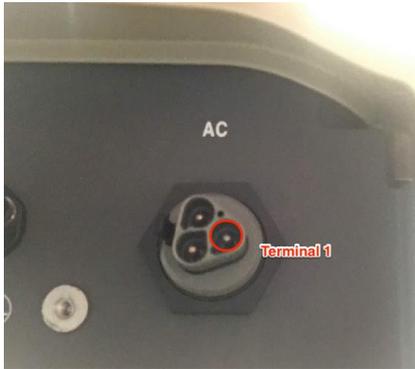
Figure 4 External terminal

Continuity Test: Use a multimeter to check continuity from the AC connector to the inverter circuit board terminal, i.e. from the external terminal (Figure 4) to the internal terminal (Figure 5). The resistance value should be 0 (Figure 6).

1. Assemble the AC connector again.
2. If you have completed steps of troubleshooting for scenario 2, please take photos as above, then we can advise to replace the inverter if the test indicates that there is an internal short circuit. However, the return inverter will be tested in our warehouse, if the allegedly faulty inverter is found to be free of defects, Sungrow will provide a test report and charges may apply.
