Error 514 or 084 S100 Meter Communication Issues

The S100 Energy Meter is a vital component of the Sungrow hybrid system. This document uses an SH5K-20 inverter as an example for explanation.

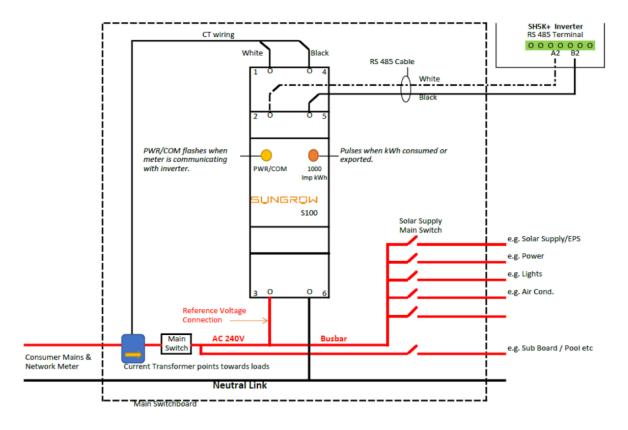
Connection Diagram for the Energy Meter - Sungrow SH5K-20:

It tells the inverter when to charge or discharge the battery, when to go into off-grid mode, Export Control, and when to use AC to charge the battery. It is therefore vital that it is connected properly. *It must be on the same phase as the inverter.*

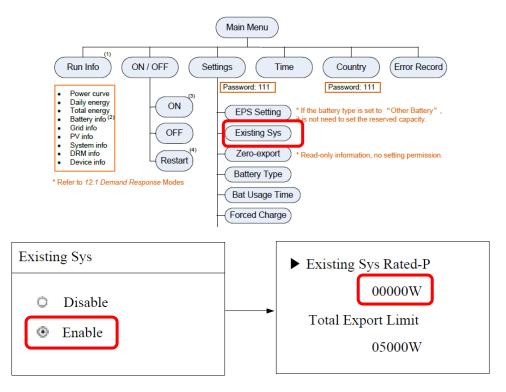
Error 084 is the reverse sensor connection caused the communication error, which can be caused by:

not setting the existing system if there is another inverter, or

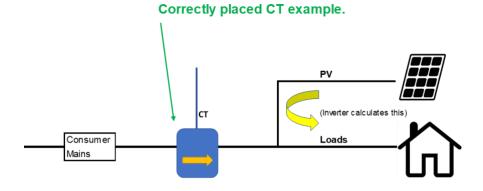
if the CT clamping is not pointing away from the grid to the inverter and to loads that are on the same phase as the inverter.

If the issue persists, please take photos testing on site and contact Sungrow Service Department on 1800 786 476.
