## Error 714 Battery communication issue

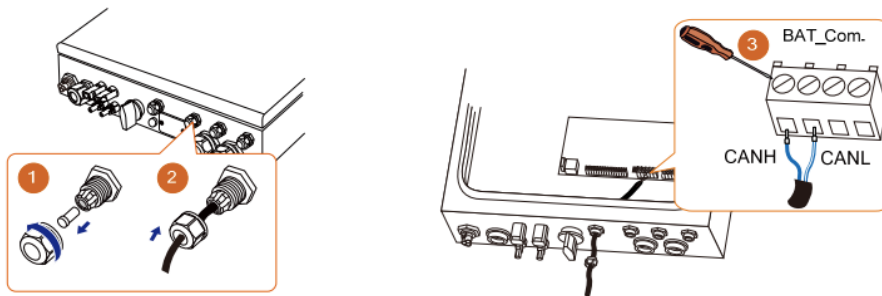
2. the battery communication cable connection.

Check that the supplied cable is used and that the connections for the inverter are correct. Test the continuity of the battery communication cable. If it is faulty and the please try another battery communication cable.
