Fault 010 islanding fault

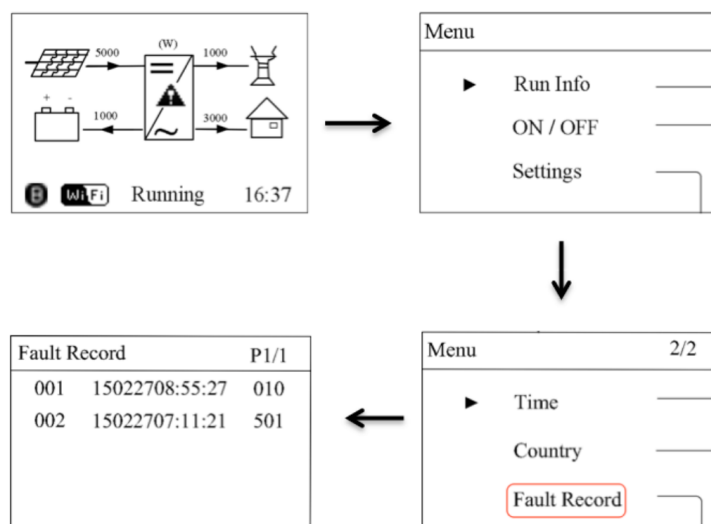
Figure 1: inverter fault records

4. Check the AC connectors as above for step 3.
5. Tap ESC/down (for less than half a second) to view the current faults (if any, see Figure 1) and take a photo of the screen.

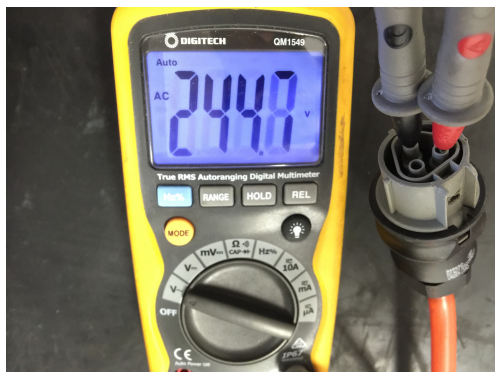
Figure 1: external AC voltage

If the technician measures that the AC connectors have a voltage (Figure 1), then we recommend to take the inverter cover off and measure the internal voltage (Figure 2).

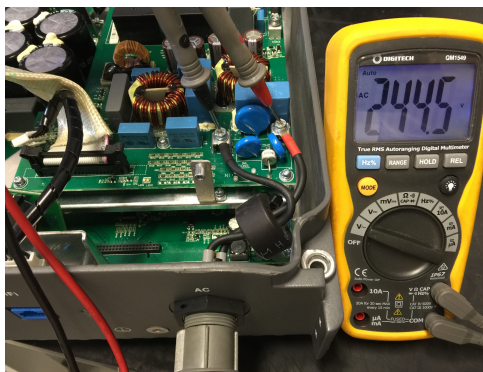
Figure 2: internal AC voltage

If the technician measures that the internal circuit board terminals have a voltage (Figure 2), but the LCD still shows fault 010, then the inverter needs to be replaced.

If the technician measures that the internal circuit board terminals have no voltage, then there will be an issue with the connection or installation.

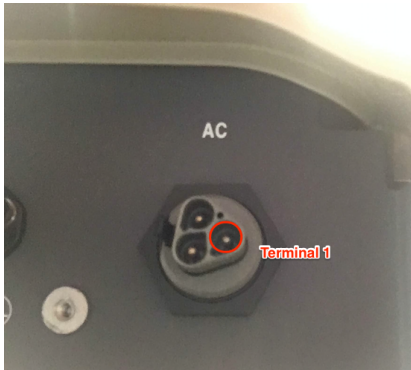
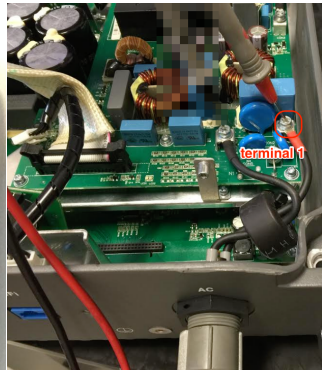
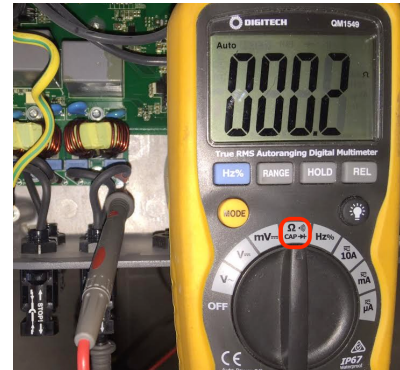
1. Short-circuit test: use a multimeter to measure the resistance from the AC connector to the inverter circuit board terminal, i.e. from the external terminal (Figure 3) to the internal terminal (Figure 4). The resistance value should be 0 (Figure 5).

2. Assemble the AC connector again.

If you have completed steps of troubleshooting for scenario 2 and the inverter still does not have any light on, please take photos as above, then we will advise to replace the inverter. However, the return inverter will be tested in our warehouse, if the allegedly faulty inverter is found to be free of defects, Sungrow will provide a test report and charges may apply.
