PV Abnormal Alarm on Three-Phase Inverters

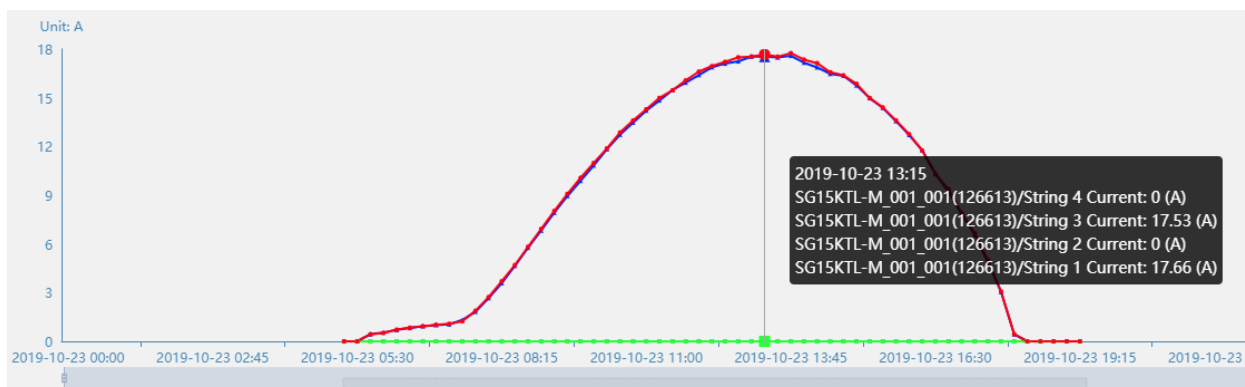
These inverters have 4 string inputs, 2 for each MPPT. If the current for any one of the strings exceeds 15A, PV abnormal Alarm will occur. This can occur if the strings have been paralleled up on the roof and brought down as one string. Figure 1 shows an example.

Figure 1 String Current Exceeds 15A

In the case above, strings had been paralleled up on the roof and hence, total current exceeded the 15A limitation. This issue can be fixed by bringing down 2 individual strings so that both inputs are utilised on the MPPT (**Sungrow recommends**).

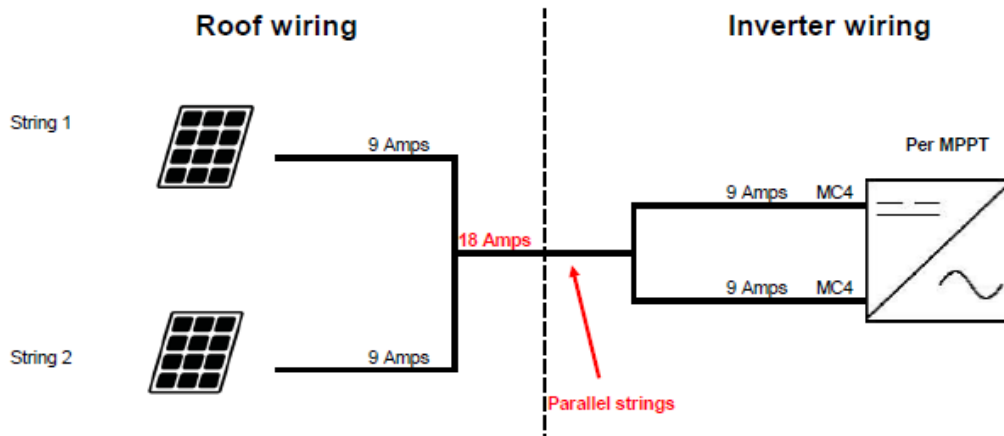
Figure 2 Splitting Current at DC Isolator

Alternatively, the current could be split at the bottom of the DC isolator (Figure 2).

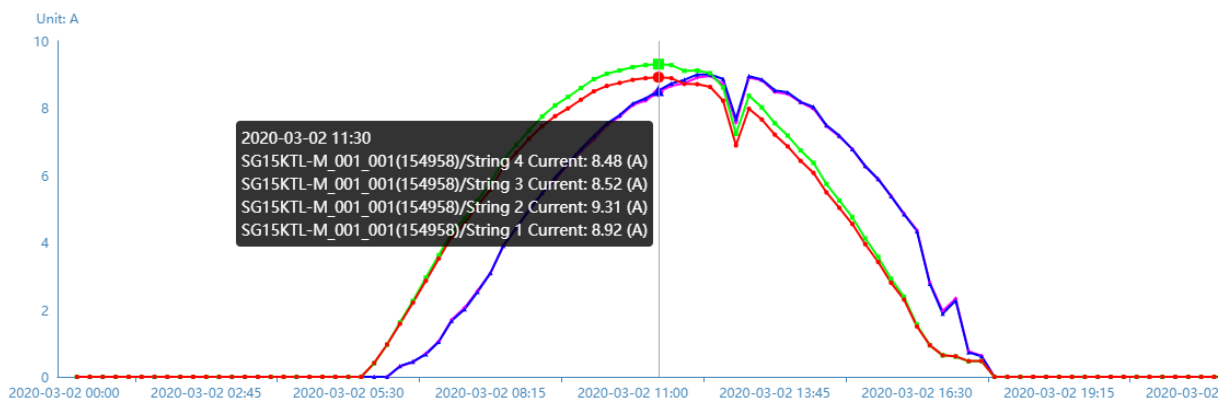
This will result in current being distributed evenly across the strings hence, eliminating the alarm altogether (Figure 3).

Figure 3 String Current Distributed Evenly

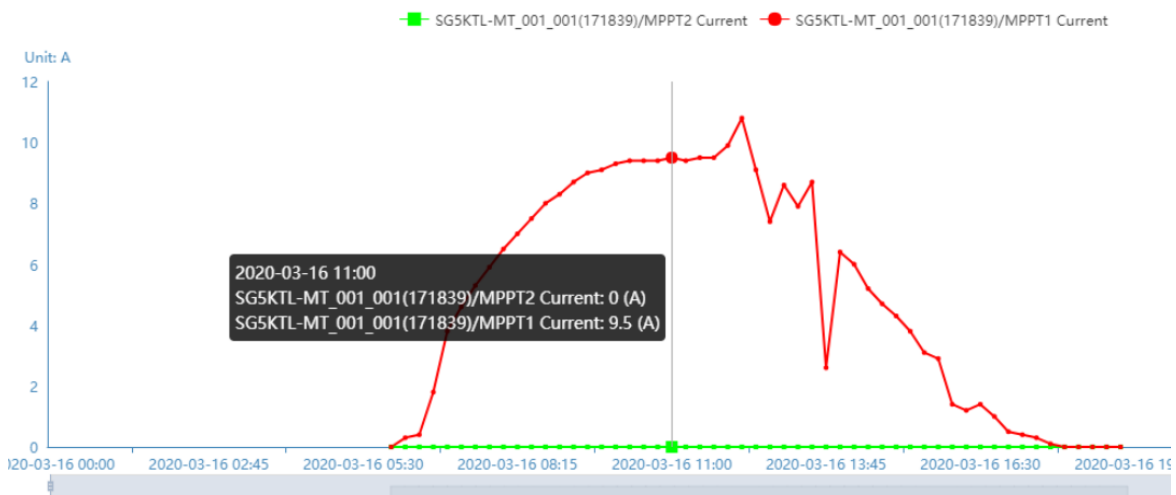
Another reason for the PV Abnormal Alarm to occur is if, the current difference between MPPT's is greater than 6A. This is to warn the customer that there is a significant difference between the MPPT currents and there may be something unusual. An example of a possible issue can be possible shading which can cause the current to drop significantly. An example is in the image below.

Figure 4 MPPT Current Difference > 6A

Since the difference of current between the MPPT currents is greater than 6A, the fault will occur.

In this case, the strings should be checked to ensure that they are performing normally. If the current on the MPPTs is normally, String Detection setting can be turned off under local access (on-site) to avoid the fault. Steps are as follows:

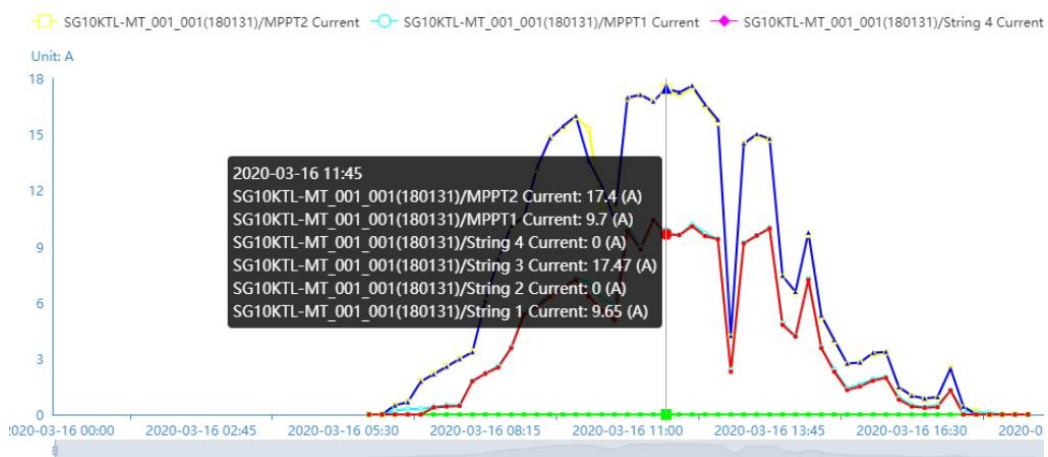
Figure 8 Special Scenario

Figure 8 shows an example where 2 string have been paralleled on the roof and brought down into string 3 (MPPT 2) Hence, causing the string current to exceed 15A. Moreover, for MPPT1 one string has been brought down. Therefore, resulting in a current difference greater than 6A between MPPTs

To resolve this issue, resolution steps for both scenarios need to be carried out. Once fixed, the current in the string should be split and the fault should stop from reappearing. Figure 9 shows an example.

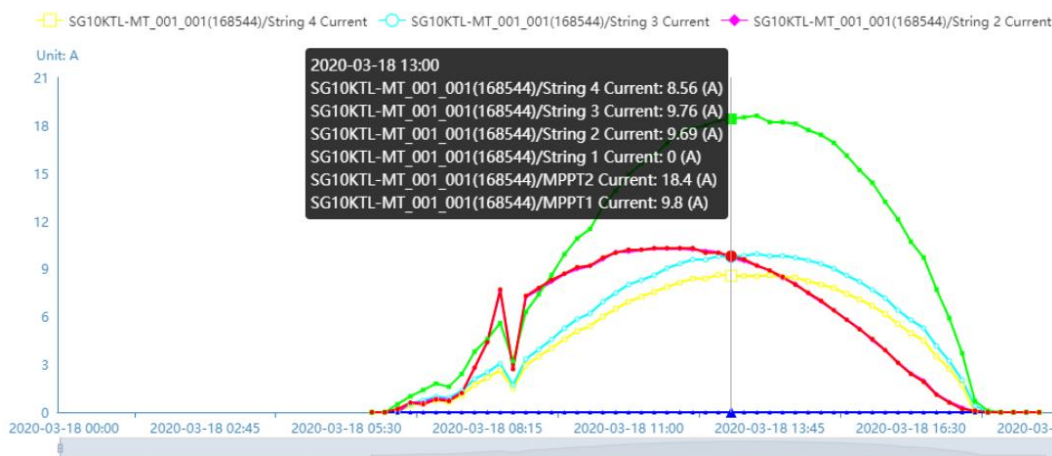
Figure 9 String and MPPT Current
