074 Troubleshooting Guide

Sungrow has recently been selling the Crystal G1 inverter which come with a detachable screen i.e. an eShow module. On this series of inverters, customers may come across a 074 fault which is just a communication issue between the inverter and the eShow module. **It is important to note that this fault does not affect the production of the inverter in any way.** The inverter will continue to make produce power which can be verified by the flashing green light on the inverter.

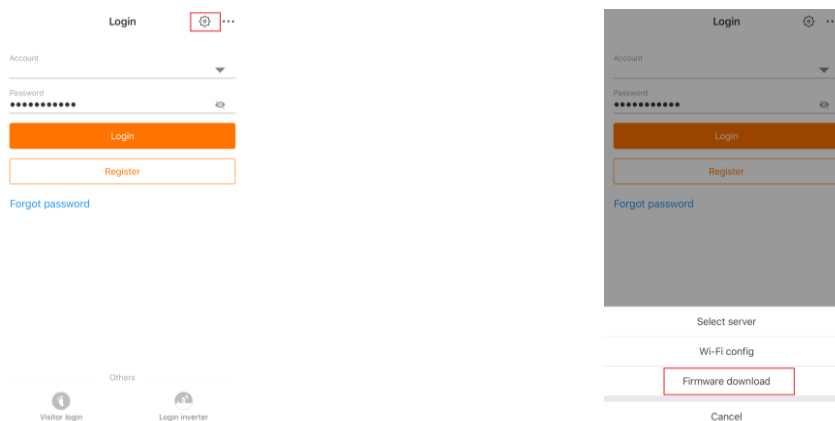
The firmware for the upgrade can be downloaded using the iSolarCloud APP. Click right top setting gear and select the 'Firmware download' (Figure 1& Figure 2).

Figure 1 Home Screen

Figure 2 Firmware Download

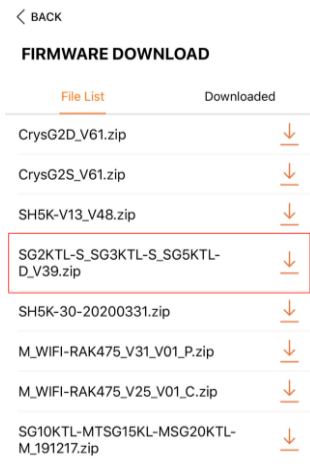
A message on the bottom of the screen will be displayed once the firmware file has downloaded successfully. This can also be checked under the “Downloaded” tab.

Figure 3 Home Screen

Figure 4 Firmware Download

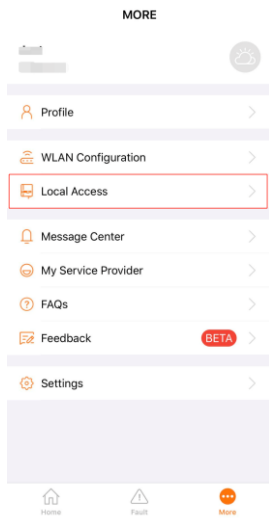
Once the download is complete, the firmware must be uploaded to the inverter. This can be done by connecting to the inverter directly through local access. First step is to connect the phone to the Sungrow network i.e. “SG-Bxxxxxxxxx”. Once connected, Local Access can be found on the “Login Page” of the app or the “More” section after logging in.

Figure 5 Local Access

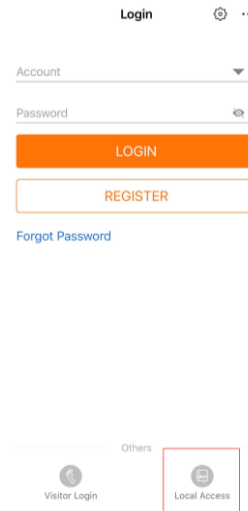
Figure 6 Device Upgrade

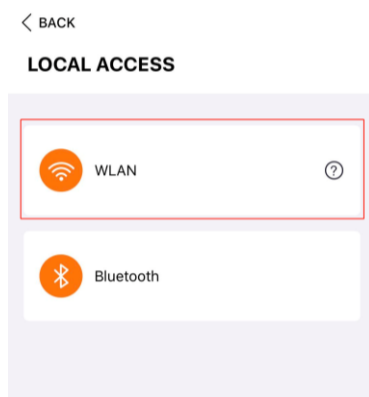
On clicking Local Access, select **WLAN** and then login using “**user**” as the account and “**pw1111**” as the password.

Figure 7 Local Access

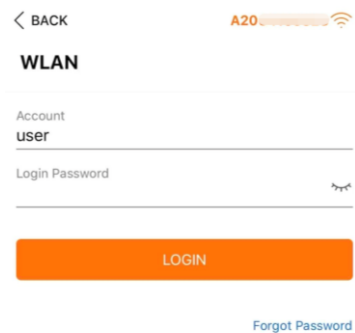
Figure 8 Device Upgrade

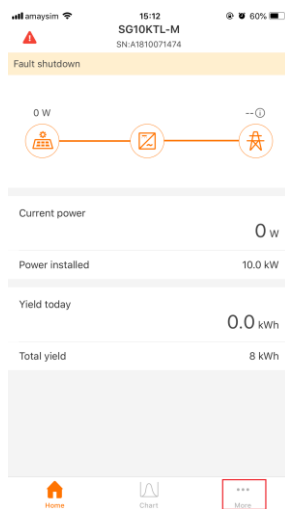
On logging in, click on “**More**” and then Firmware upgrade.

Figure 9 Local Access

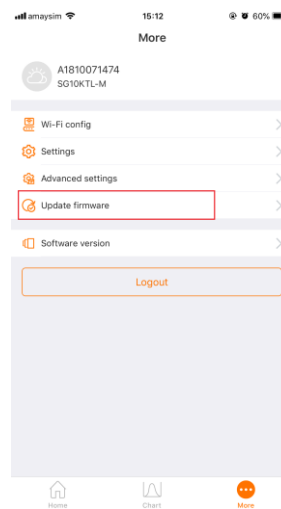
Figure 10 Device Upgrade

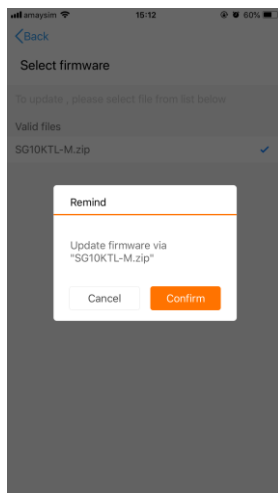
The relevant file can then be selected and uploaded. On completion, a message will pop up showing the upgrade as successful.

Figure 11 Upload Firmware

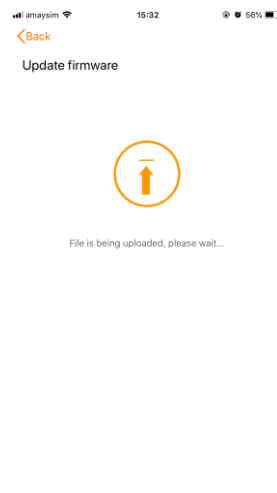
Figure 12 Firmware Upgrade

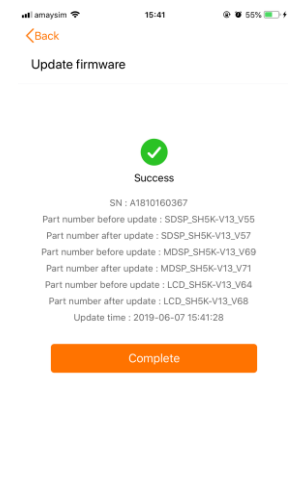
Figure 13 Upgrade Successfully
